# **WETLAND DELINEATION REPORT**

## **PAR FORE PROPERTY CITY OF FITCHBURG, DANE COUNTY, WISCONSIN**

**December 21, 2007**

**NRC Project # 007-0275-01**

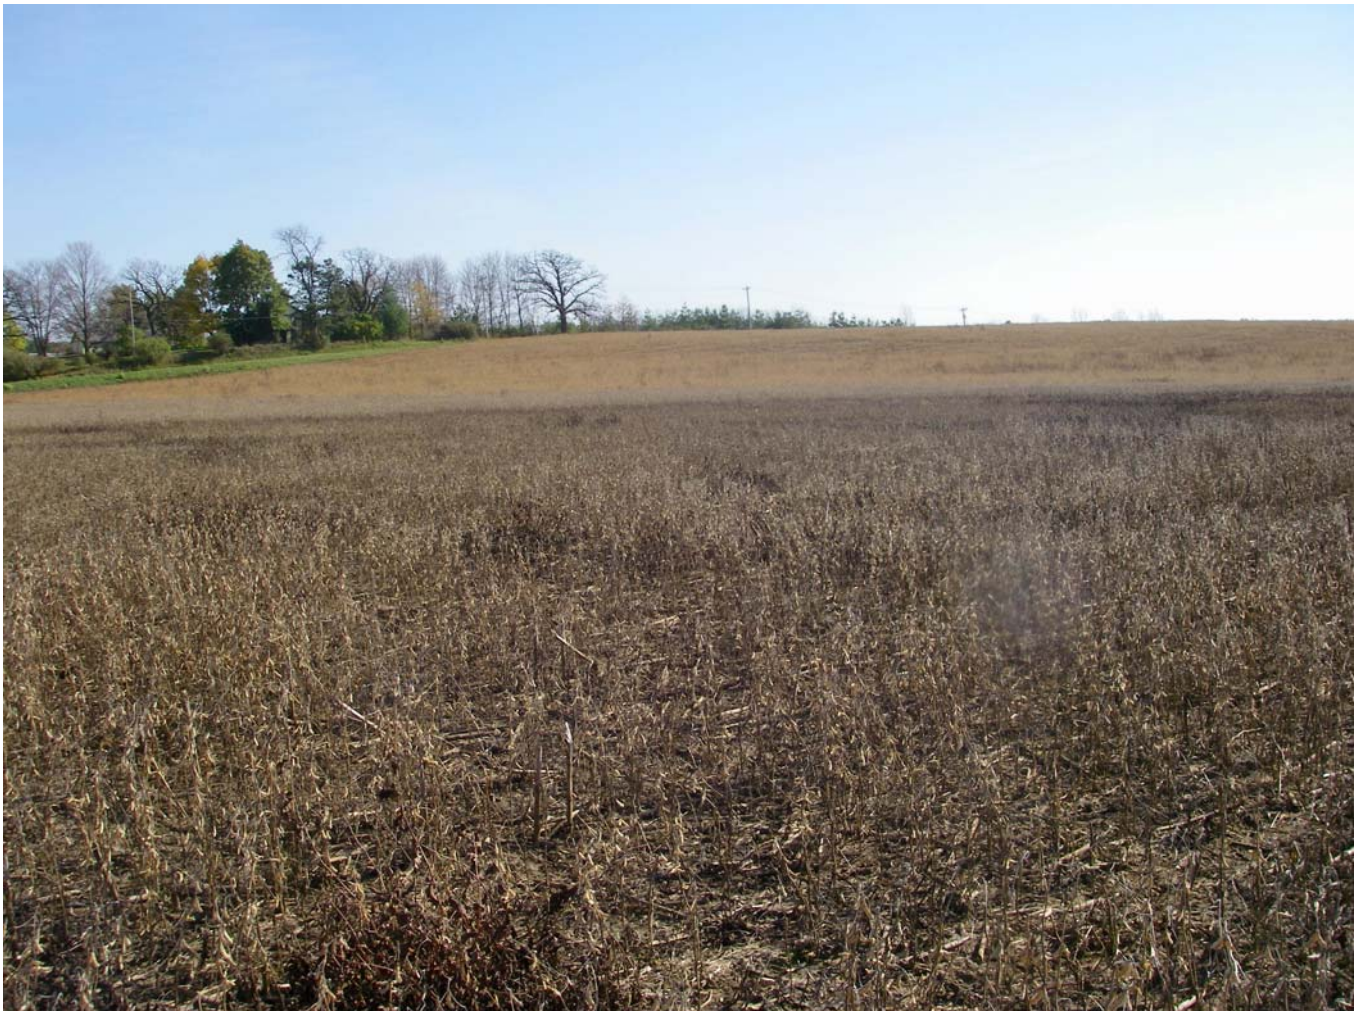
Photo 02. W-3 View SE.JPG

W-3 is also located within a low lying depressional area. There are no surface water drainage feature inlets to the wetland and the wetland is fed primarily by surface water sheet flow. Water within the wetland drains to the east to a culvert lying under Larson Road located within the eastern edge of the wetland and is elevated approximately one foot above the wetland (Photos 01 & 09). Water passes through the culvert to the eastside of Larson Road into an excavated area (Photo 07). *Surface water features east of Larson Road were only evaluated from the road since we did not have permission to access this property. Visibility east of Larson Road is limited by dense tree and shrub cover.* There does not appear to be a continuous ditch east of Larson Road, but rather just an excavated pit. When water levels exceed the banks, water sheet flows through a mesic woodland, eastward into a larger wetland complex. Based on what could be observed from the roadside there does not appear to be a defined surface water connection between the culvert at Larson Road and the larger wetland complex east of Larson Road and the mesic woodland appears to be an upland woodland. The wetland complex east of Larson Road appears to have a surface water connection via an agricultural ditch to wetlands adjacent to Swan Creek.

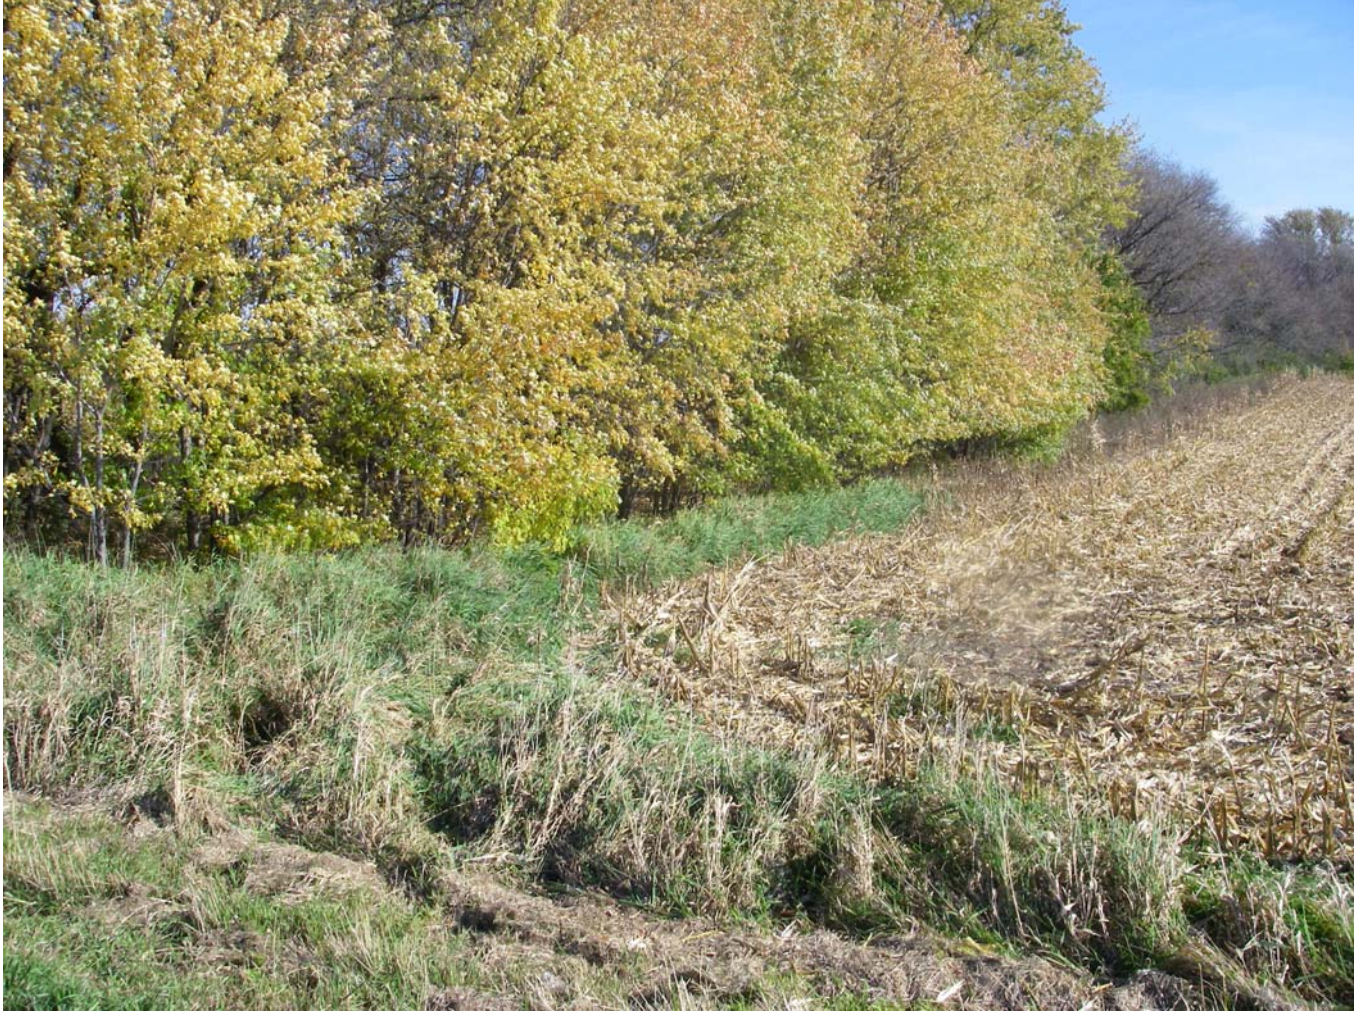
Photo 11. W-2 Tree line.JPG

W-2 lies within a subtle depression and is not adjacent to any defined surface water inlet or outlet drainage feature (Photos 11 & 12). Surface water runoff sheet flows from the surrounding landscape into this low lying area. A culvert lying under CTH MM is located approximately 50 feet north of the wetland, however the culvert is elevated at least 1 to 2 feet above the wetland elevation and there are no surface water drainage features associated with the culvert.

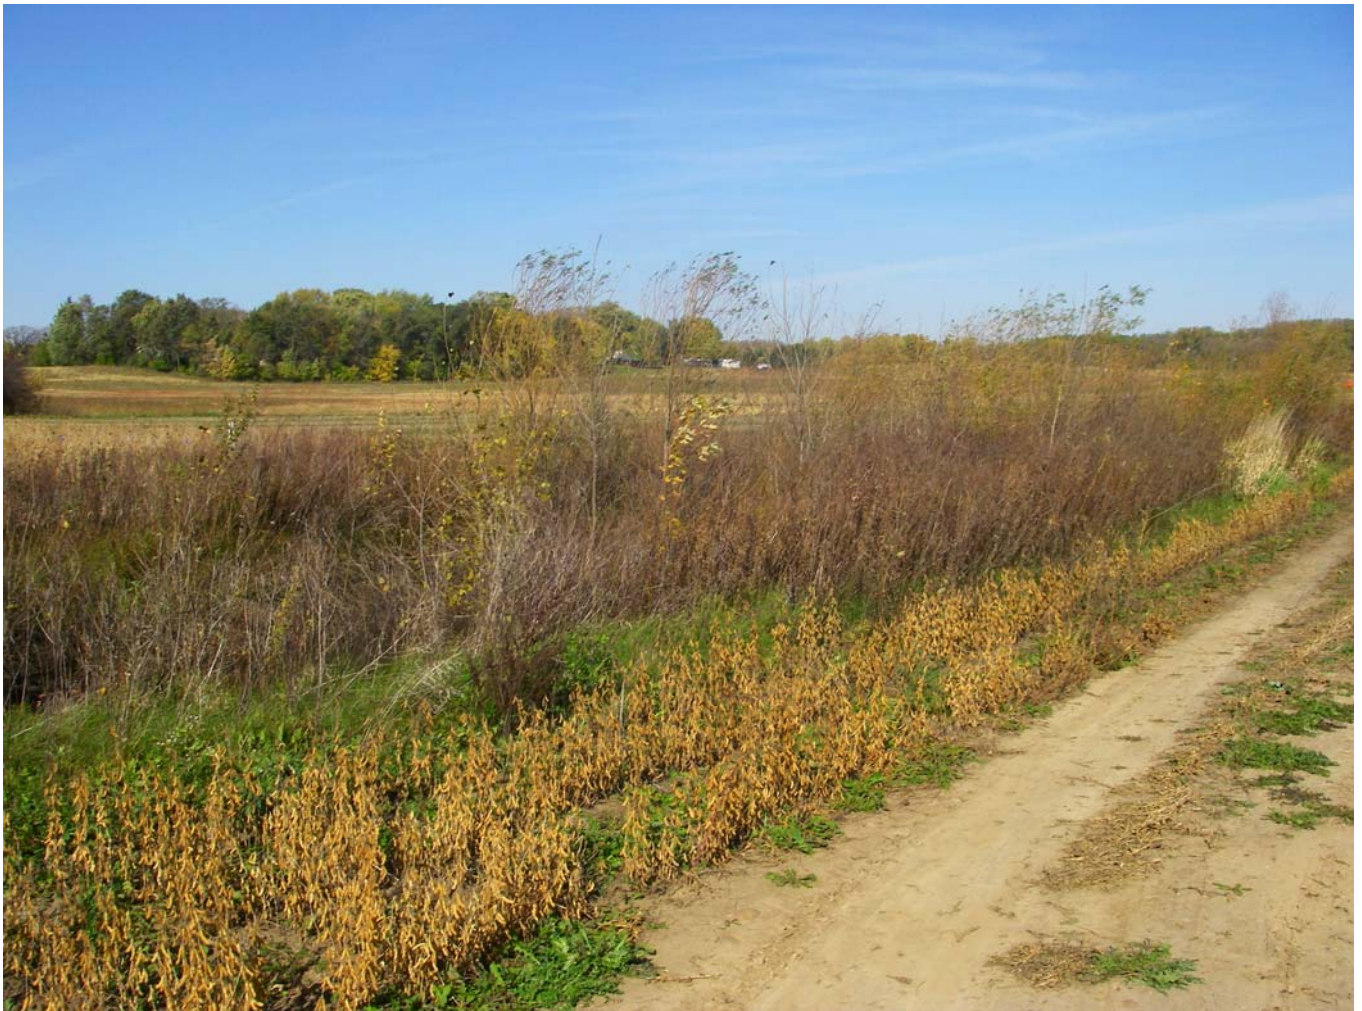
Photo 16. W-1 Pond Edge.JPG

W-1 is an excavated pond within a depressional area (Photos 16 & 17). A relatively undefined, upland grass swale is located adjacent to the southern edge of the pond that drains south under Goodland Park Road via a culvert. The swale is dominated by brome grass. The grass swale becomes more defined approximately 200 feet south of Goodland Park Road where it transitions into wetland and discharges into a larger wetland complex adjacent to Swan Creek. The upland grass swale adjacent to the pond is elevated approximately 3 feet above the OHWM of the pond, limiting any surface water flow out of the wetland pond to substantial precipitation events. The upland drainage swale does not contain a defined bed or bank and there were no noticeable drainage patterns observed.
